**Flood Control Project Maintenance
Levee Inspections**
LMA District Cover Sheet
Spring 2018 Levee Inspection Results

Reclamation District No. 0544 Upper Roberts Island

Spring 2018 Levee Inspection Results

Waterway			Bank	Unit Miles
Unit No. 01 San Joaquin River			Left	6.05
	Spring (March - May)	Summer (June - August)	(September - November) Fall	Winter (December - February)
Unit Maintenance Rating (Fall Only)				
Date of Inspection	4/26/2018 - 4/26/2018			
DWR Inspector	Richard Willoughby			
Accompanied By	Richard Toy KSN

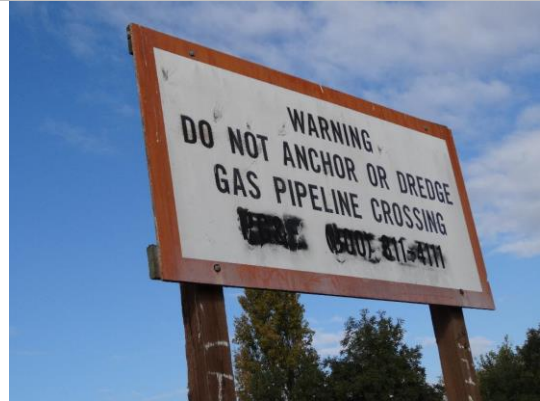
Photo 3 of 3 : UCIP_SP_2018_41906_41711.jpg

Comment Code						
Inspector Comment						
FS_ID:41906 DS_ID:22640 EP_NO: 4116 Repair Type: Non-Urgent Crossing Status: Found UCIP Comments: Need to contact owner to determine status.- a signboard on waterside shoulder and across the river.- no indicators on landside. FIELD_STRUCT_DESC: 8.625-inch steel natural gas pipeline through the levees and under the river, 3.9 feet below the crown. Waterside (WS) slope rock revetted. (Plans for installation of an 8.625-inch gas line under the San Joaquin River and through the levees authorized under Permit No. 4116, 1962 - Pacific Gas and Electric Company [PG&E]). [Additional Reference(s): DWR Levee Log, 2005. USACE San Joaquin O&M Manual 7, April 1964, (HLM 0.01)]. FS Date: 10/29/2013

WS view: closer view of a signboard indicating a gasoline on levee shoulder.

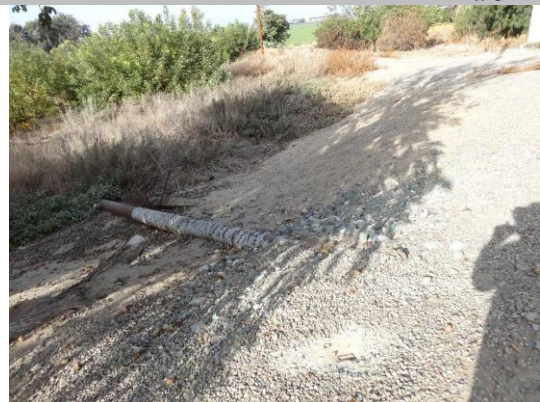
Photo 1 of 3 : UCIP_SP_2018_23851_41728.jpg

LM Start	0.01	Rating **	M	Issue No.	153	
LM End	0.01	Issue Type +	En	Location *		
Category	Supplemental			GPS Latitude/Longitude		
				Start	End	
Item	DWR UCIP Field Study			37.870296 °	37.870296 °	
				-121.329826 °	-121.329826 °	
DWR ID						
Comment Code						
Inspector Comment						
FS_ID:23851 DS_ID:24713 EP_NO: N/A Repair Type: Non-Urgent Crossing Status: Found UCIP Comments: Appears abandoned.May need proper abandonment.Pipe exposed on landside slope. FIELD_STRUCT_DESC: *ABANDONED* 12-inch steel pipe of an unknown purpose through the levee, 2 feet below the crown. Appears abandoned. Only visible on the landside (LS) slope. No pipe or other features visible on the waterside (WS). FS Date: 10/29/2013

LS view: exposed 12-inch steel pipe on levee slope. Appears abandoned.

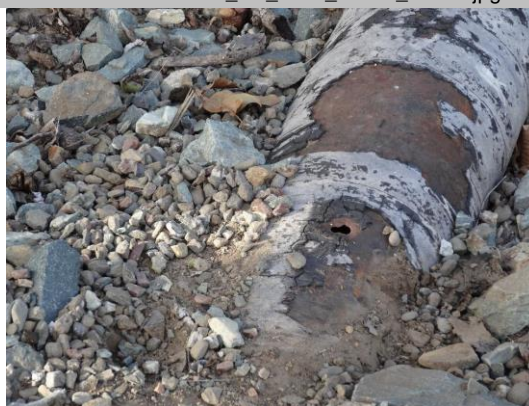
Photo 2 of 3 : UCIP_SP_2018_23851_41727.jpg

LS view: a 12-inch steel pipe on levee slope. Holes on the pipe, appears abandoned.

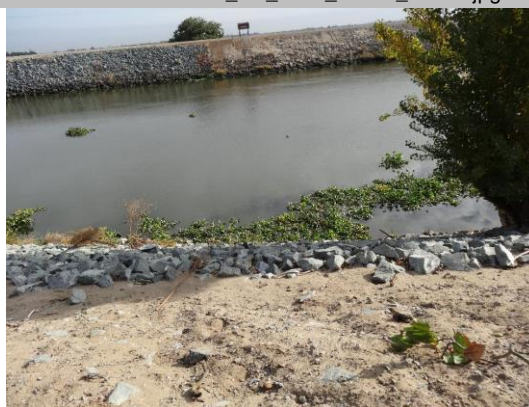
Photo 3 of 3 : UCIP_SP_2018_23851_41726.jpg

WS view: no pipe and appurtenances found on waterside.

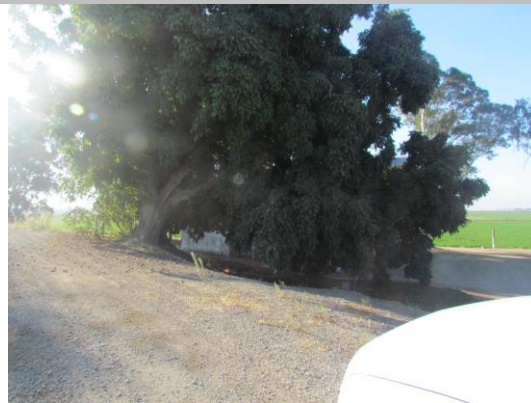
Photo 1 of 1 : SP_2018_RD0544_108_2_20180323_00002.jpg

Looking southwest at untrimmed tree on landward slope.

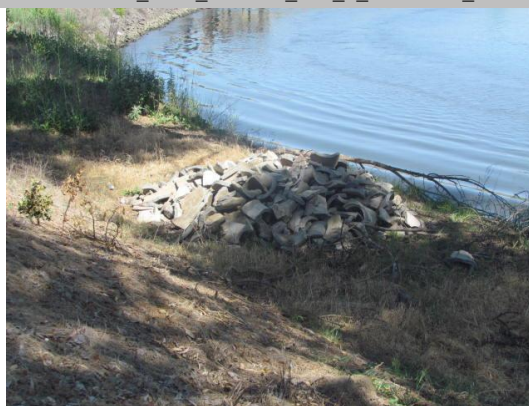
Photo 1 of 1 : SP_2018_RD0544_108_1_20180323_00001.jpg

LM Start	0.45	Rating **	M	Issue No.	1
LM End	0.45	Issue Type +	En	Location *	WS
Category	Earthen Levee			GPS Latitude/Longitude	
				Start	End
Item	Encroachments			37.864713 °	37.864713 °
				-121.326708 °	-121.326708 °
DWR ID	DWR_RD0544_01_f_2013_1				
Comment Code					
MA : Material					
Inspector Comment					
Old broken concrete pipes on waterside berm.

Looking northeast at broken concrete piping on waterward berm.

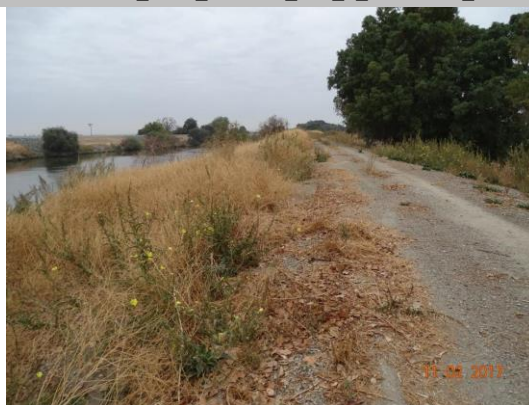
Photo 1 of 2 : SP_2018_RD0544_108_3_20180323_00003.jpg

LM Start	0.45	Rating **	C	Issue No.	6
LM End	0.45	Issue Type +	Ma	Location *	WS
Category	Earthen Levee			GPS Latitude/Longitude	
				Start	End
Item	Encroachments			37.864713 °	37.864713 °
				-121.326708 °	-121.326708 °
DWR ID	DWR_RD0544_01_f_2013_6				
Comment Code					
PR : Prunings					
Inspector Comment					
Broken tree limbs on waterside slope and berm.

Looking southeast at the waterside slope.

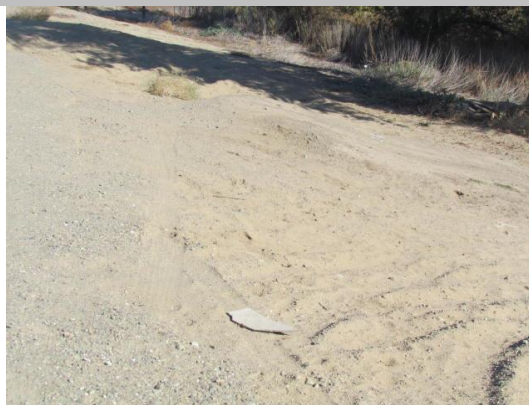
Photo 3 of 3 : SP_2018_RD0544_108_119_20180323_00091.jpg

LM Start	1.50	Rating **	U	Issue No.	119 (cont)	
LM End	1.51	Issue Type +	Ma	Location *	WS	
Category	Earthen Levee			GPS Latitude/Longitude		
				Start		End
Item	Slope Stability			37.854844 °		37.854564 °
				-121.321090 °		-121.321031 °
DWR ID	DWR_RD0544_01_f_2015_119					
Comment Code						
S2 : Repair the levee slope damaged by foot traffic and prevent access where possible.						
Inspector Comment						
Damaged levee slope due to fishermen using slope as a ramp.

Looking southeast at damaged waterward slope fall 2015

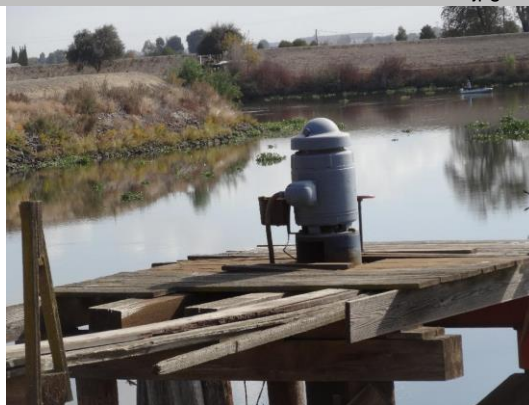
Photo 2 of 3 : UCIP_SP_2018_51351_41785.jpg

WS view: pump on wooden pile structure in the stream.

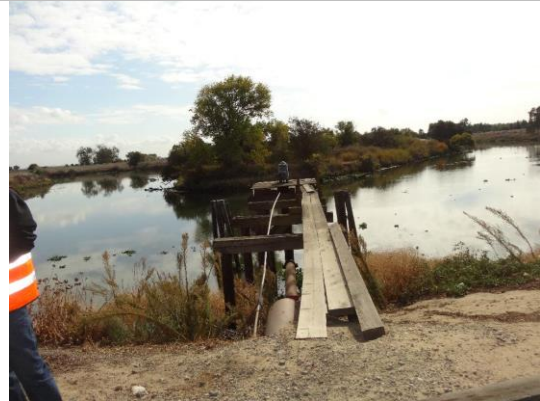
Photo 3 of 3 : UCIP_SP_2018_51351_41784.jpg

WS view: depression on levee shoulder near walkway. Half of the walkway stripped off.

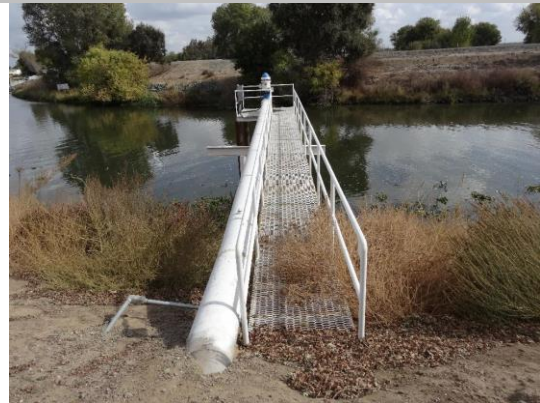
Photo 1 of 3 : UCIP_SP_2018_51352_42007.jpg

WS view: steel pipe, walkway to the pump, conduit (bottom left) on levee slope.

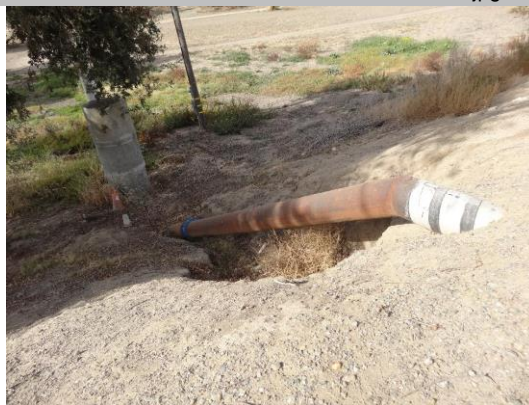
Photo 3 of 3 : UCIP_SP_2018_51352_42005.jpg

LS view: exposed pipe, concrete standpipe (left), service pole (top right) and eroded slope.

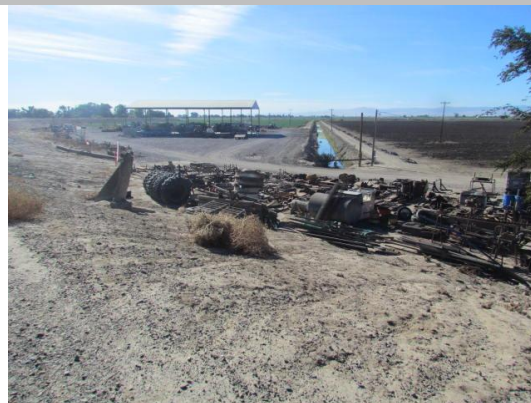
Photo 1 of 1 : SP_2018_RD0544_108_68_20180323_00049.jpg

Looking west at equipment at landward toe.

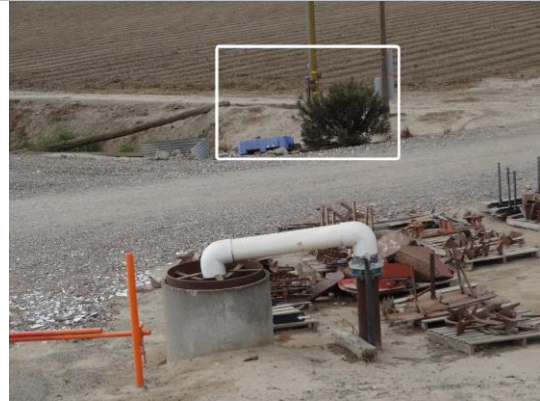
Photo 3 of 3 : UCIP_SP_2018_46671_44834.jpg

LS view: pump on drainage ditch bank about 140 ft from the levee.

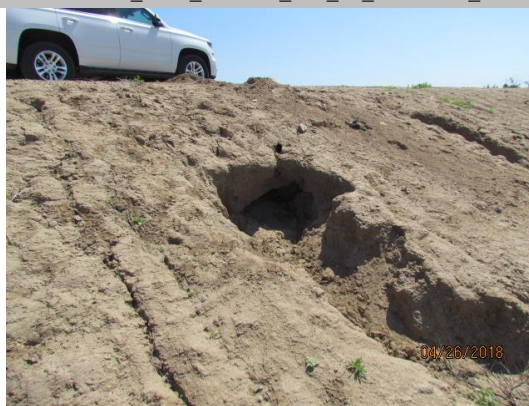
Photo 1 of 2 : SP_2018_RD0544_108_15_20180427_00181.jpg

Looking southeast at slope damage on landward slope. (Spring 2018)

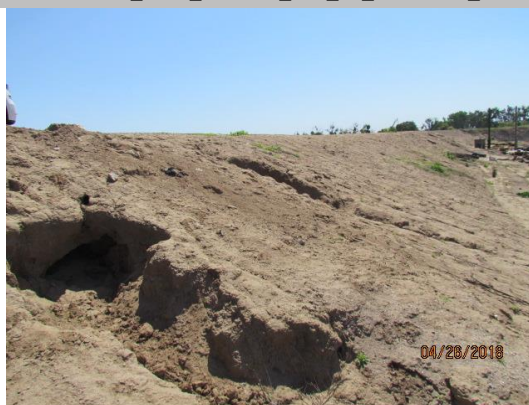
Photo 2 of 2 : SP_2018_RD0544_108_15_20180427_00182.jpg

Looking south at slope erosion on landward slope. (Spring 2018)

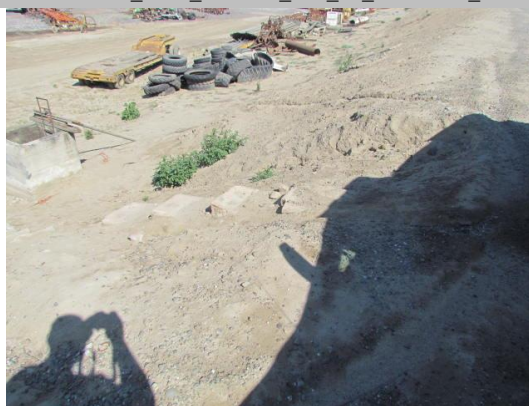
Photo 1 of 2 : SP_2018_RD0544_108_60_20180323_00043.jpg

Looking north at slope damage on landside slope.

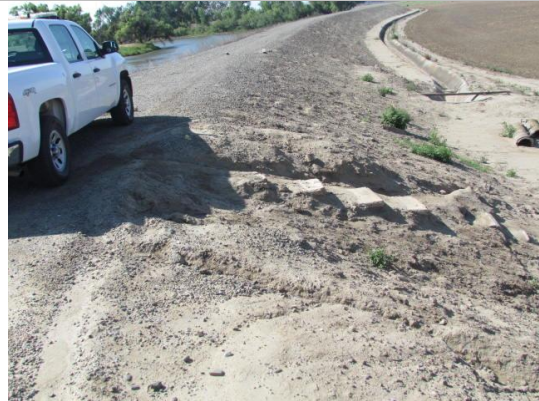
Photo 2 of 2 : SP_2018_RD0544_108_60_20180323_00044.jpg

Looking south at slope damage on landside slope.

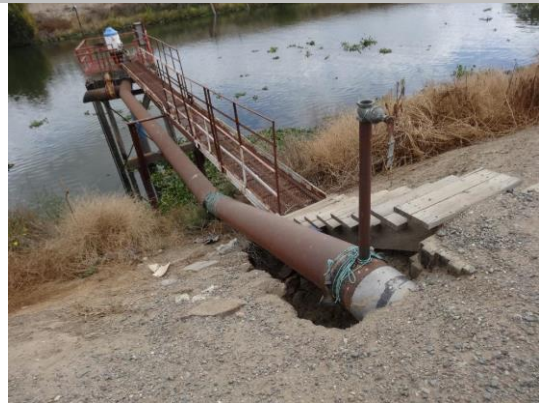
Photo 1 of 3 : UCIP_SP_2018_51361_44839.jpg

WS view: exposed pipe, walkway to pump, and pump on pile structure in the stream.

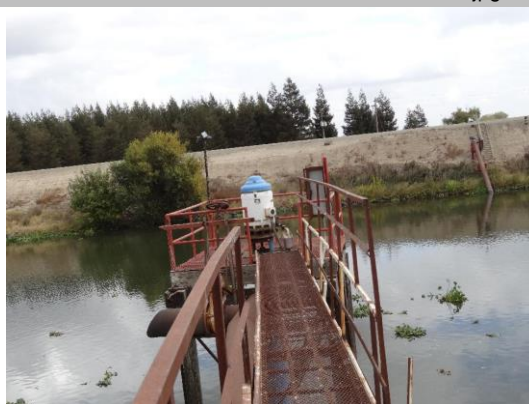
Photo 3 of 3 : UCIP_SP_2018_51361_44837.jpg

WS view: walkway to pump and pump on pile structure in the stream.

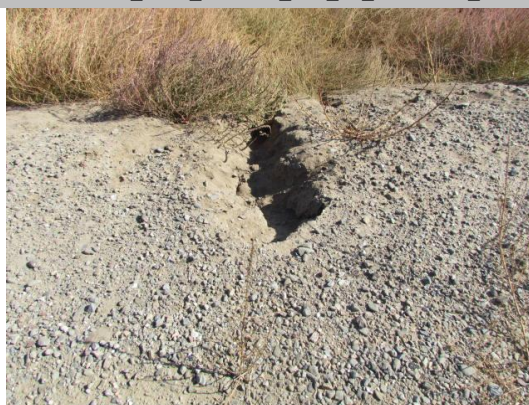
Photo 1 of 1 : SP_2018_RD0544_108_76_20180323_00053.jpg

Looking east at slope damage on waterward slope.

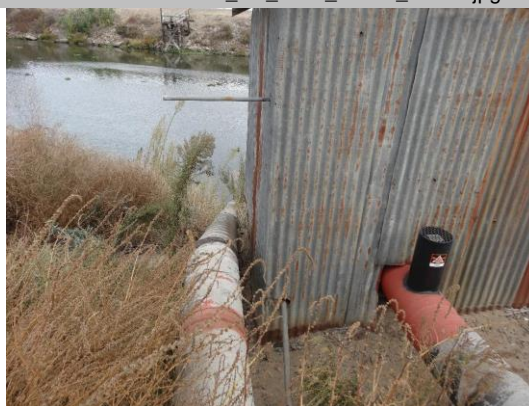
Photo 3 of 3 : UCIP_SP_2018_51366_44843.jpg

WS view: exposed steel pipe (right) with flow meter near pump house.

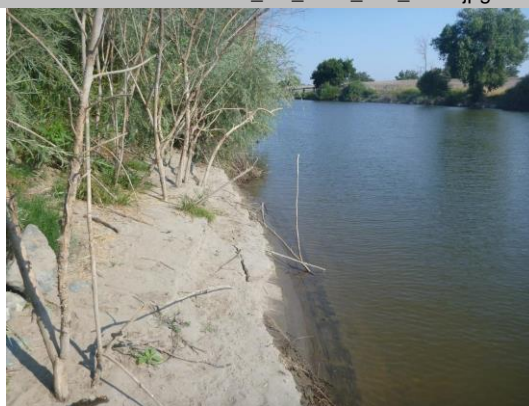
Photo 3 of 3 : LEVAL_SP_2018_565_4745.jpg

LM Start	3.69	Rating **	A/W	Issue No.	133
LM End	3.73	Issue Type +	Ma	Location *	
Category	Supplemental			GPS Latitude/Longitude	
				Start	End
Item	2017 Storm Damage			37.831300 °	37.830700 °
				-121.312600 °	-121.312300 °
DWR ID	DWR_RD0544_01_f_2017_133				
Comment Code					
Inspector Comment					
Levee Evaluation Comments					
Description:Slope protection repairs are needed along the waterside slope due to erosion and riprap displacement from high water. Based upon levee inspections, it was determined the waterside levee slope is eroding, deteriorating, and degrading. The eroded levee sections need to be restored back to design standards to prevent further deterioration and damage.					
Site ID No:564					
Site Designation:LMA-470					
Repair Type: Erosion					
Rating:Area of Concern					
Field Date:8/11/2017					
Notes: big rodent holes on levee slopes

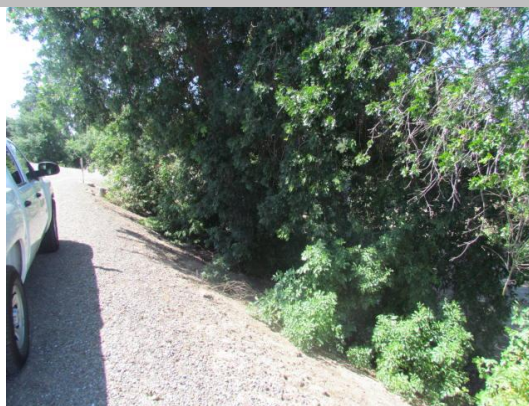
Photo 1 of 1 : SP_2018_RD0544_108_112_20180323_00081.jpg

Looking southwest at dense trees on landward slope and toe.

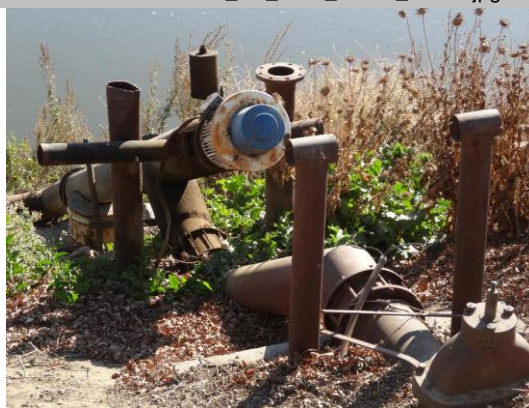
Photo 1 of 3 : UCIP_SP_2018_42962_42877.jpg

WS view: slant pump on steel framed support, gate valve, and headwall on levee slope.

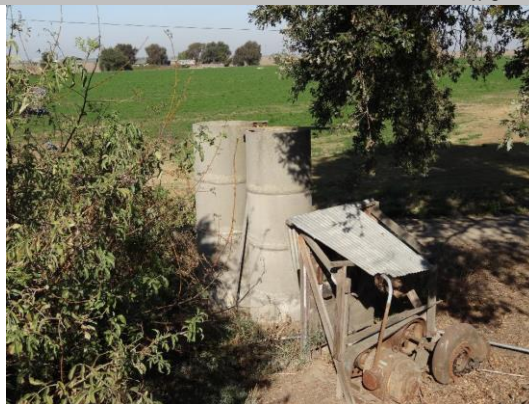
Photo 3 of 3 : UCIP_SP_2018_42962_42875.jpg

LS view: two concrete standpipes and abandoned pump on levee slope.

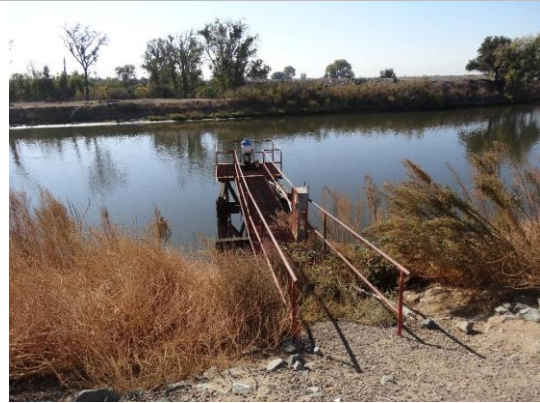
Photo 1 of 3 : UCIP_SP_2018_51384_42872.jpg

WS view: pump on pile structure, walkway to the pump on levee slope.

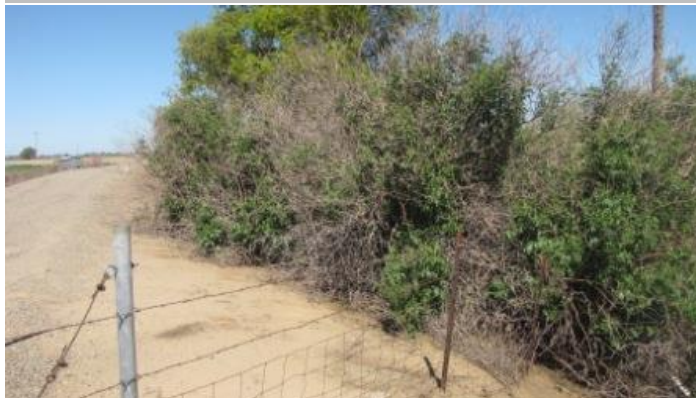
Photo 2 of 2 : SP_2018_RD0544_109_10_20180323_00015.jpg

Looking south at elderberries on landside slope and toe.

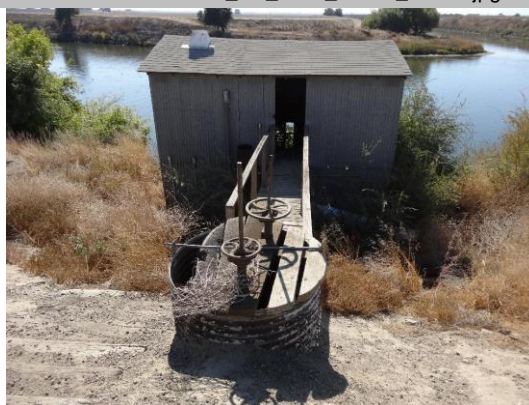
Photo 1 of 3 : UCIP_SP_2018_24288_42947.jpg

WS view: slide gate in CMP riser, walkway, and pumphouse on levee slope.

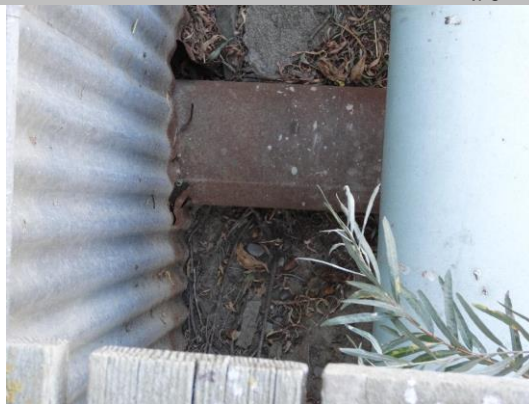
Photo 3 of 3 : UCIP_SP_2018_24288_42945.jpg

WS view: abandoned 10" steel pipe daylights on levee slope.

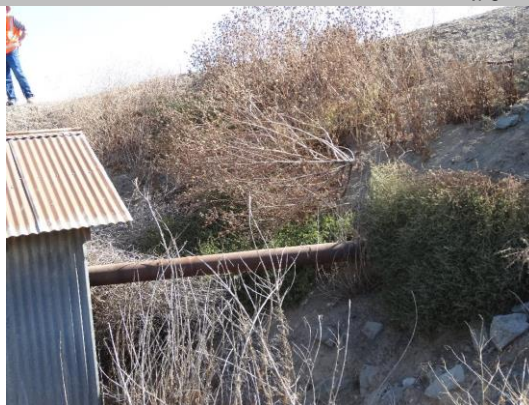
Photo 2 of 3 : UCIP_SP_2018_24907_44894.jpg

LS view: pipe daylighting on levee slope.

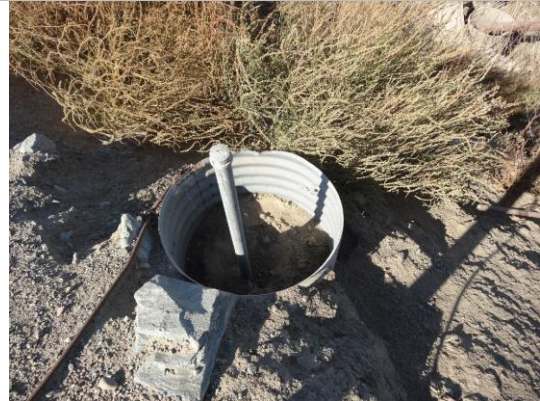
Photo 3 of 3 : UCIP_SP_2018_24907_44893.jpg

WS view: air vent on CMP riser on levee shoulder.

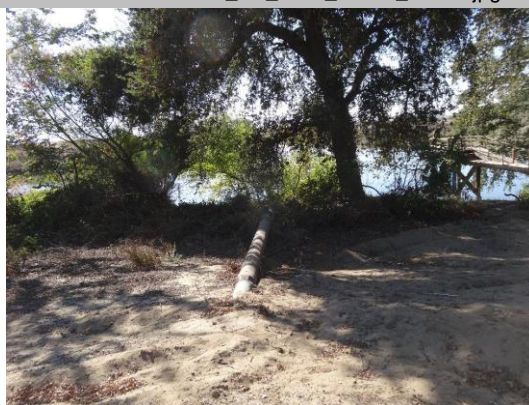
Photo 1 of 3 : UCIP_SP_2018_24293_42965.jpg

WS view: exposed steel pipe on berm.

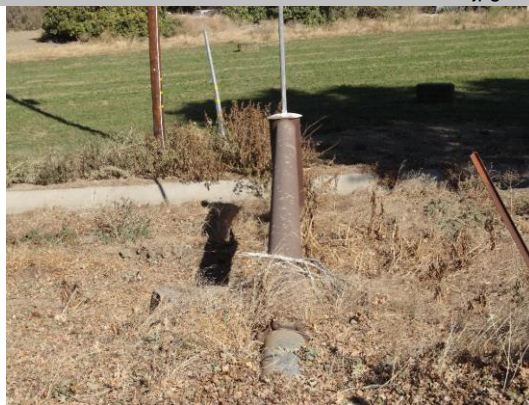
Photo 3 of 3 : UCIP_SP_2018_24293_42966.jpg

LS view: exposed steel pipe and air vent on levee berm. No pump found.

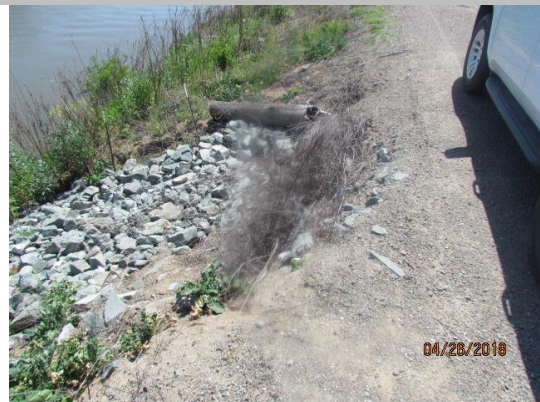
Photo 1 of 5 : SP_2018_RD0544_109_69_20180427_00132.jpg

Looking south at erosion on shoulder. (Spring 2018)

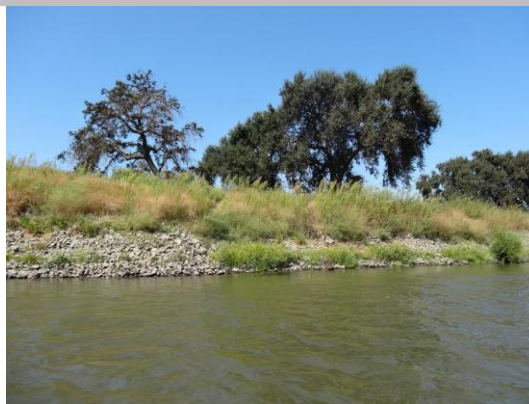
Photo 2 of 2 : SP_2018_RD0544_109_7_20180323_00007.jpg

Front view of the pocket erosion.

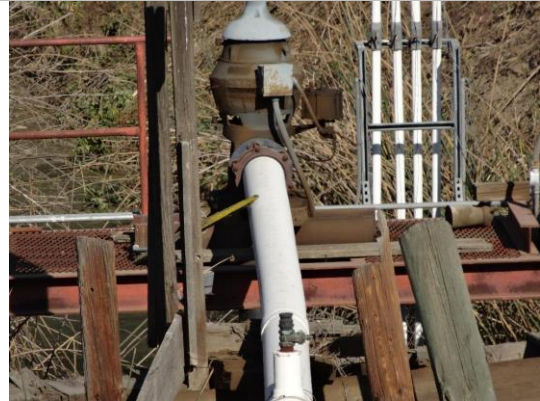
Photo 3 of 3 : UCIP_SP_2018_24908_44896.jpg

LS view: pump on steel platform over drainage ditch.

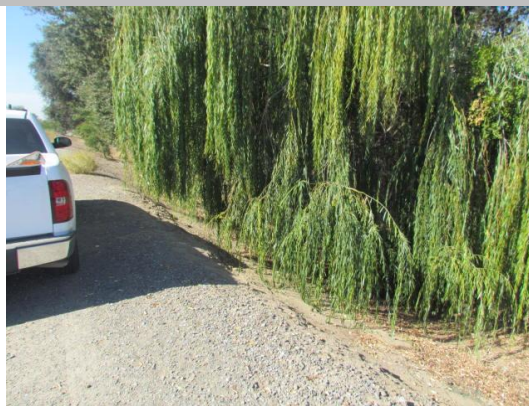
Photo 1 of 1 : SP_2018_RD0544_109_55_20180323_00045.jpg

Looking southwest at untrimmed trees on landward slope and toe fall 2015.

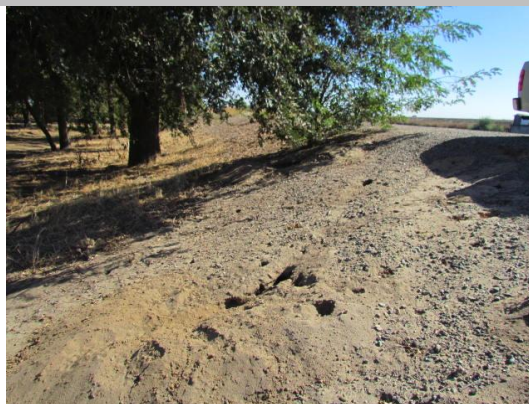
Photo 1 of 2 : SP_2018_RD0544_109_67_20180323_00051.jpg

Looking northeast at typical view of rodent holes on landward slope.

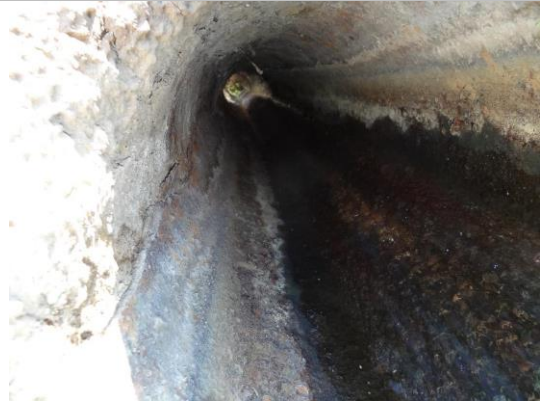
WS view: inside view of hole in deteriorated pipe.
